**EVALUATION OF NON-DESTRUCTIVE TECHNIQUES FOR
CORROSION DETECTION IN CONCRETE EXPOSED
TO A MARINE ENVIRONMENT**

**Prepared in cooperation with the State of Hawaii Department of Transportation,
Highways Division and U.S. Department of Transportation, Federal Highway
Administration**

Research Report UHM/CEE/05-04

May 2005

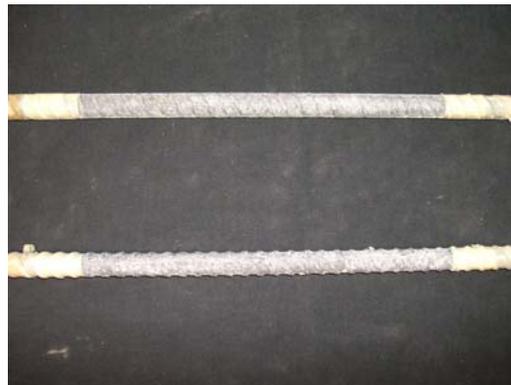
Figure 7.352 - Bars, top

Rheo6 #8 – The outside of the specimen looked in fair condition. There were some discolorations on the top surface. There was no corrosion located on the inside of the specimen. The half cell potential values showed all of them fell into the 10% probability region. The voltage readings showed that the specimen had not failed. The inspection concluded the corrosion to be none.

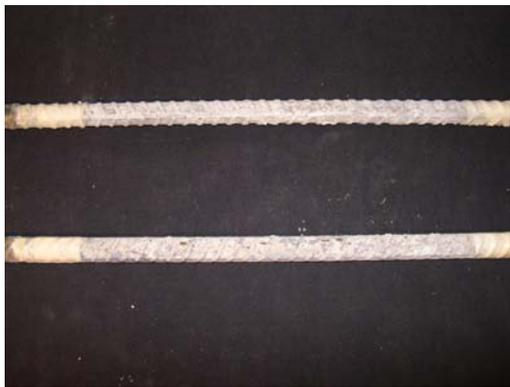
Figure 7.355 - Bars, bottom

SF1 #8 – From the outside the specimen looked in excellent condition. Both bars have a nominal amount of corrosion in the form of pits along the bottoms of the bars. The half cell potential values all fell into the range of 10% probability. The voltage results concluded that the specimen had not reached failure. The inspection concluded the corrosion to be none.

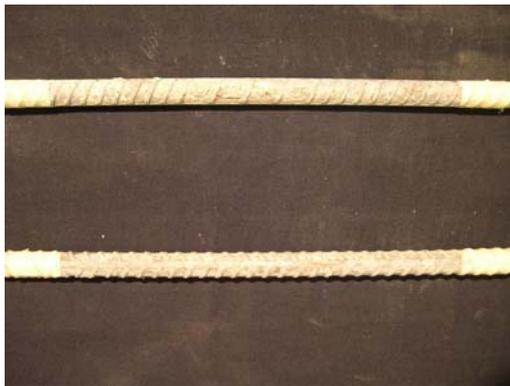
Figure 7.359 - Bars, bottom

SF2 #8 – The outside of the specimen looked in good condition. There were scattered corrosion pits on the bottoms of both bars. The half cell potential values all fell into the 10% probability range. The voltage readings showed the specimen did not fail. The inspection concluded the corrosion to be none.

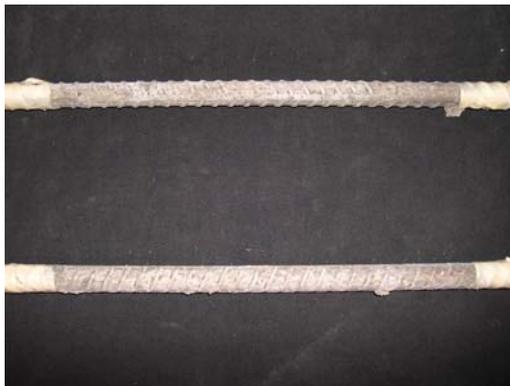
Figure 7.367 - Bars, bottom

SF3 #8 – The top surface contained small discolorations. Both bars had a fair amount of scattered corrosion and pits along the bottoms. The half cell potential values all fell into the 10% probability range. The voltage results indicated the specimen had not failed. The inspection concluded the corrosion to be minor.

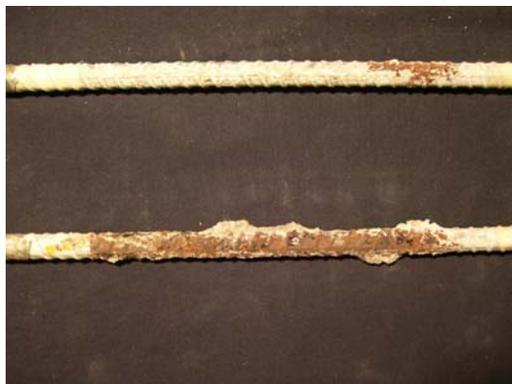
Figure 7.375 - Bars, bottom

SF5 #5 – The visual inspection revealed multiple cracks on the top surface above the right bar. In the vicinity of the cracks there was also an area of discoloration. Cracks were found on the right side of the specimen as well. The right bar was well covered in corrosion on the bottom. The top of the bar was also covered with a large area of corrosion. The left bar had a small area of corrosion on the bottom with a few other spots. The half cell potential values all fell into the uncertain range. The voltage readings had reached failure. The inspection concluded the corrosion to be moderate to significant.

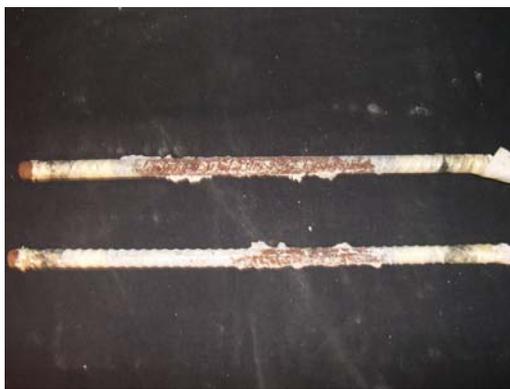
Figure 7.379 - Bars, bottom

SF5 #7 – The outside of the specimen appeared to be in good condition. The bottom of the left bar was almost completely covered in corrosion. The top of the bar had some corrosion along the edges. The bottom of the right bar was about half way covered in corrosion. The top of the bar also had some corrosion pits. The half cell potential values all fell into the uncertain range. The voltage data showed that the specimen had failed. The inspection concluded the corrosion to be moderate to significant.

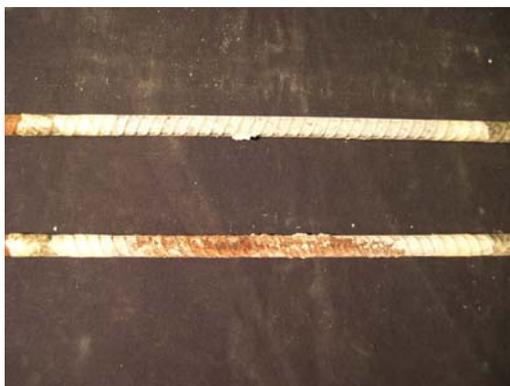
Figure 7.383 - Bars, bottom

SF5 #8 – The outside of the specimen looked to be in good condition. The majority of the corrosion appeared on the bottom of the right bar. The rest of the spotted corrosion appeared on the top of the right bar and bottom of the left bar. The half cell potential values all fell into the 10% probability range. The voltage readings showed the specimen came close to failure but it did not reach it. The inspection concluded the corrosion to be moderate to significant.

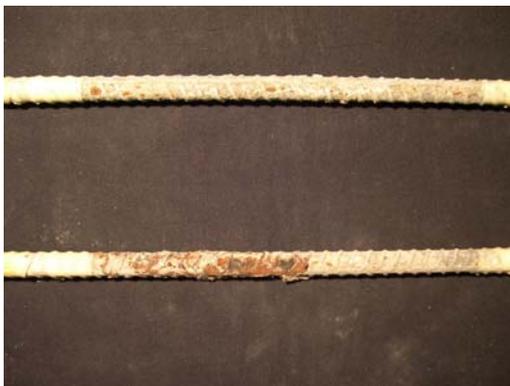
Figure 7.387 - Bars, bottom

SF6 #6 – The visual inspection showed that there was a crack on the top surface toward the front of the right bar. There was also a crack on the right side surface. The corrosion mostly appeared were the crack occurred, on the right bar toward the front. The corrosion on the top of the bar was concentrated. The corrosion on the bottom of the bar was more spaced out in the same area. There was more corrosion mostly in the forms of pits along the rest of both bars. The half cell potential values showed one value on the right side fall into the 90% probability range. The rest of the numbers fell into the uncertain range. The voltage data indicated the specimen had failed. The inspection concluded the corrosion to be moderate to significant.

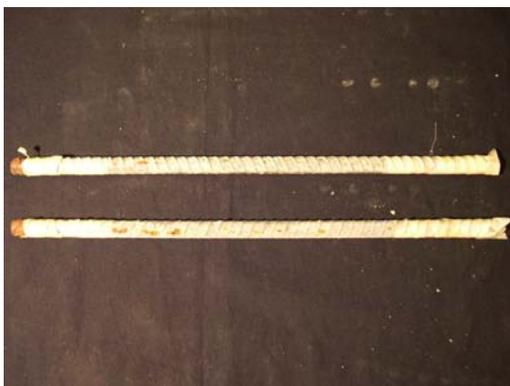
Figure 7.391 - Bars, bottom

SF6 #8 – The specimen looked to be in good condition from the outside. There were lots of pits on the bottoms of both bars. The tops of the bars also contained a few spots. The large amount of pits was due to the large amount of voids between the concrete/reinforcement interfaces. The half cell potential values all fell into the 10% probability range. The voltage data showed that the specimen had not failed. The inspection concluded the corrosion to be minor.

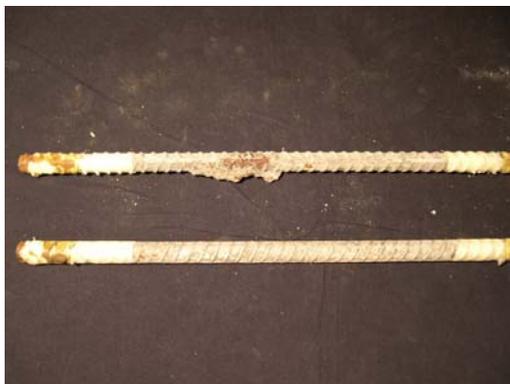
Figure 7.395 - Bars, bottom

SF7 #3 – The visual inspection found a crack on the top surface above the left bar. The top of the left bar has a 1.5 inch area of corrosion in the middle and that corrosion continues to the bottom of the bar. There was also a line of light corrosion toward the back of the bar. The right bar has a few spots and pits on the bottom of the bar. The half cell potential values all fell into the 90% probability range. The voltage readings showed that the specimen had failed. The inspection concluded the corrosion to be moderate to significant.

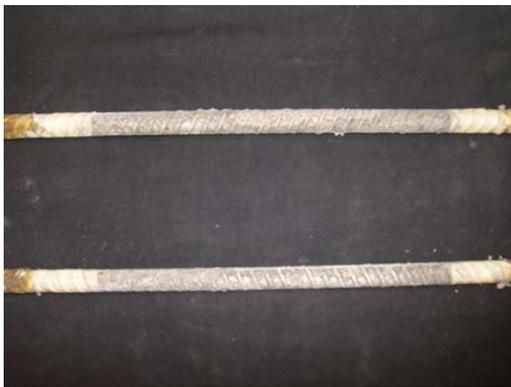
Figure 7.399 - Bars, bottom

SF7 #8 – The top surface looked in fair condition. There were some brown particles that would not come off. Both bars have corrosion on the bottoms. The left bar has a line of corrosion with pits toward the front of the bar. The right bar has multiple pits along the bar. The half cell potential values all fell into the 10% probability range. The voltage results prove the specimen had not failed. The inspection concluded the corrosion to be minor.

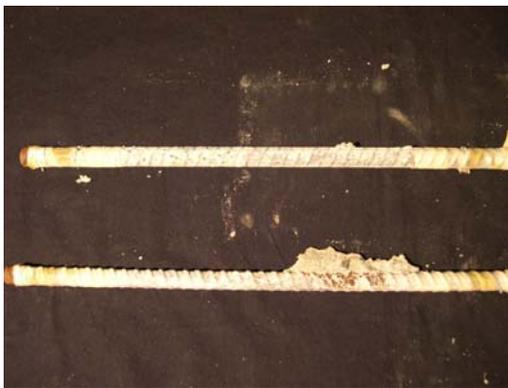
Figure 7.403 - Bars, bottom

Xyp1 #1 – The visual inspection showed a crack on the top surface running perpendicular to the right bar. At the inmost point of the crack there was a brown discoloration. The inside of the specimen showed corrosion in the same area as the crack. The top corrosion was much more concentrated and darker than the corrosion on the bottom of the bar. All of the half cell potential values fell into the uncertain range. The voltage reading showed that the specimen was very close to failure. The inspection concluded the corrosion to be moderate to significant.

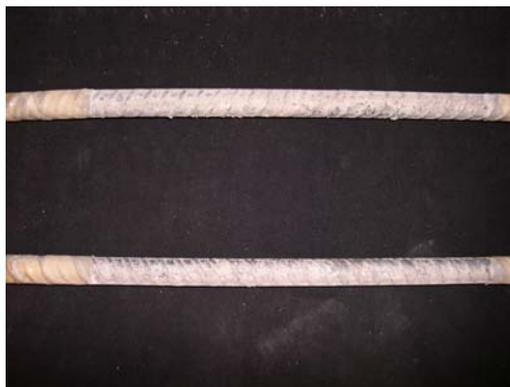
Figure 7.407 - Bars, bottom

Xyp1 #2 – The visual inspection did not show any major flaws. There was some web cracking on the top surface. The inside of the specimen was very clean. There were only a few spots of corrosion on the top of the right bar. The half cell potential numbers all fell into the 10% probability of corrosion. The voltage readings showed that the specimen was not close to failure. The inspection concluded the corrosion to be none.

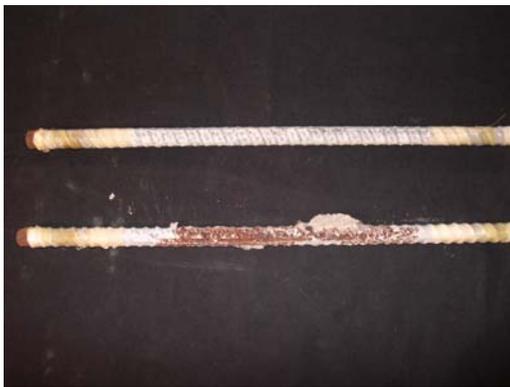
Figure 7.411 - Bars, bottom

Xyp1 #3 – The visual inspection showed a large crack [on the surface running parallel to the right bar. There were also a few smaller cracks on the right side. The bar on the right side was well covered on the bottom. The top also had a well concentrated area of corrosion. All the half cell potential values fell into the uncertain range. The voltage readings showed that the specimen had failed. The inspection concluded the corrosion to be moderate to significant.

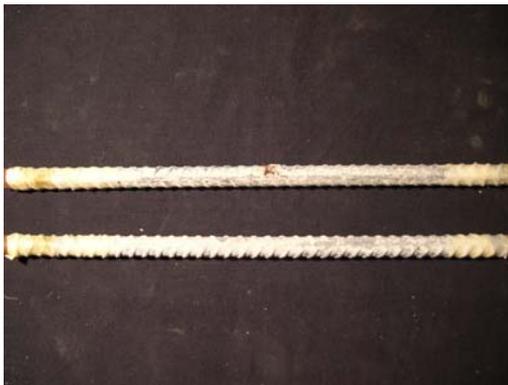
Figure 7.415 - Bars, bottom

Xyp1 #4 – The visual inspection showed some brown discoloration on the top surface in the middle but toward the right side. On the inside of the specimen there were only a small area of corrosion located in the middle of the left bar. The half cell potential values all fell into the 10% probability range. The voltage numbers were very near to failure. The inspection concluded the corrosion to be minor.

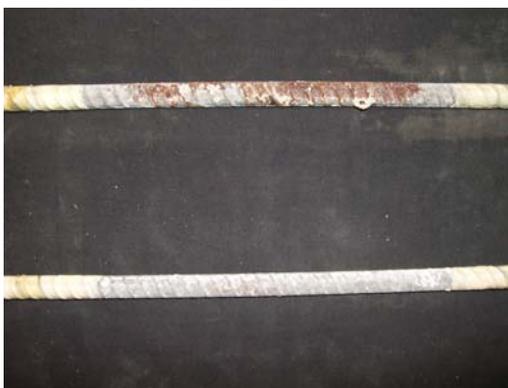
Figure 7.419 - Bars, bottom

Xyp2 #1 – The visual inspection did not show any cracks but there were a few voids. On the inside of the specimen the majority of corrosion fell on the bottom of the left bar. The top of the left bar had more pits and spots of corrosion while the bottom was well covered. The half cell potential values showed that two values on the left side fell into the 10% range while the other fell into the uncertain range. On the right side two values were uncertain and one was in the 10% range. The voltage readings had some fairly high numbers but never reached the failure threshold. The inspection concluded the corrosion to be moderate to significant.

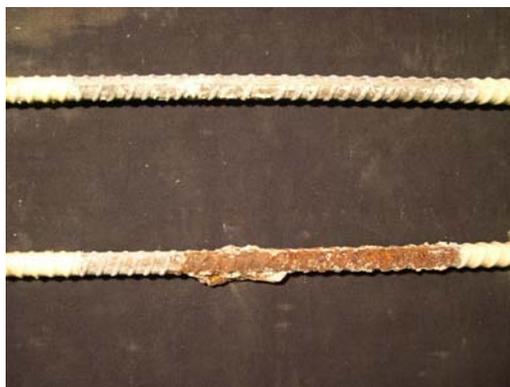
Figure 7.423 - Bars, bottom

Xyp2 #2 – The outside of the specimen showed no major flaws. On the inside both bars had corrosion on them. The right bar contained most of the corrosion on the bottom with an area of corrosion on the top. The left bar had pits along the bottom of the bar. The half cell potential numbers showed that all the values fell into the uncertain region. The voltage readings indicated that the specimen had reached failure. The inspection concluded the corrosion to be moderate to significant.

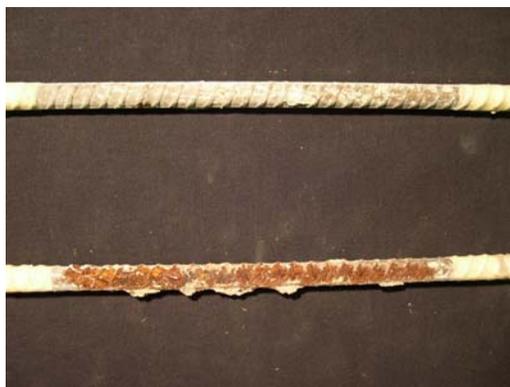
Figure 7.427 - Bars, bottom

Xyp2 #3 – The visual inspection does not show any critical flaws. Both bars have corrosion on them but only on the bottom. The bottom of the right bar was completely covered. The bottom of the left bar has pits and spots mostly toward the back of the bar. The values from the half cell potential test indicated that the numbers fell into the 10% probability region. The voltage readings came close to failure but never reached the criteria of failure. The inspection concluded the corrosion to be moderate to significant.

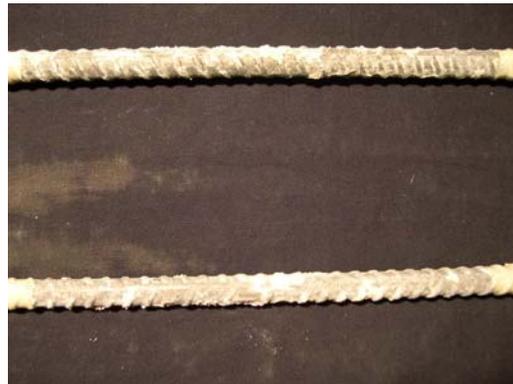
Figure 7.436 - Bars, top

Xyp4 #1 – The visual inspection showed some cracks underneath the epoxy coating on the sides. On the inside there was only a few pits on the bottom of the left bar. The half cell potential numbers all fell into the 10% probability range. The voltage numbers showed that the specimen was not close to failure. The inspection concluded the corrosion to be minor.

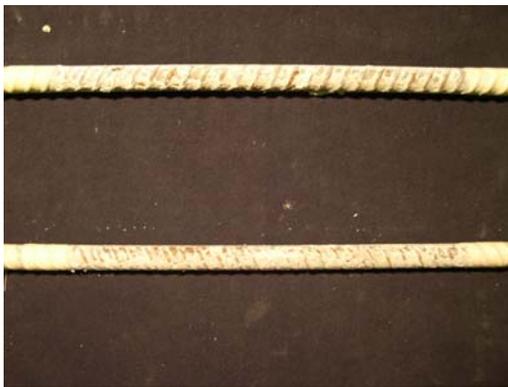
Figure 7.439 - Bars, bottom

Xyp4 #2 – The outside of the specimen looked in excellent condition. Both bars showed some corrosion. The left bar had some corrosion on the top in the middle on the edges. The bottom of both bars had corrosion along the ribs of the steel. The half cell potential values all fell in the uncertain range. The voltage readings showed that the specimen was getting closer to failure but not yet there. The inspection concluded the corrosion to be minor.

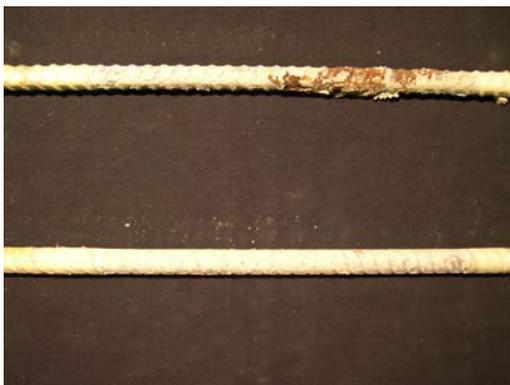
Figure 7.443 - Bars, bottom

Xyp4 #3 – The visual inspection showed a crack toward the back on the left side of the specimen. On the inside there was about a four inches area of corrosion on both the top and bottom of the left bar. The half cell potential readings showed that all the numbers fell into the uncertain range. The voltage values indicated that the specimen had failed. The inspection concluded the corrosion to be moderate to significant.

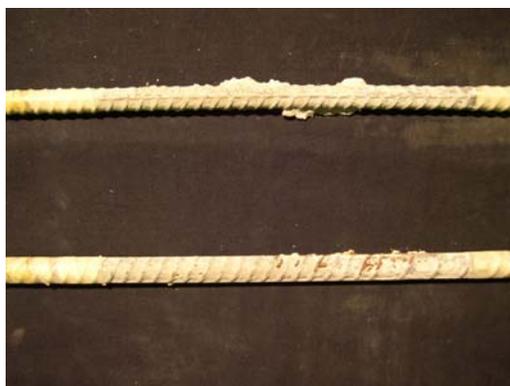
Figure 7.447 - Bars, bottom

Xyp4 #4 – The outside of the specimen looked in good condition. The majority of corrosion was located on the right bar. The top of the right bar has a one inch long discoloration. The bottom of both bars had sparse corrosion. The two half cell potential values on the left side fell into the uncertain range and the other in the 10% probability range. The values on the right side all fell into the uncertain range. The voltage readings showed that the specimen had reached failure. The inspection concluded the corrosion to be moderate to significant.

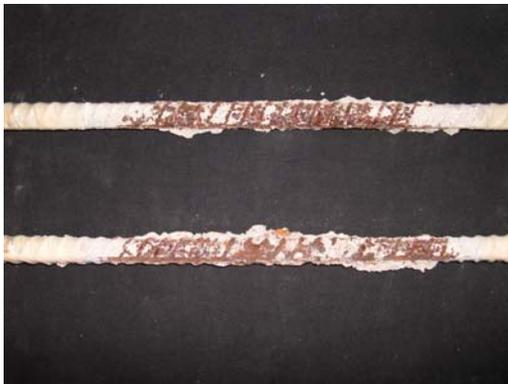
Figure 7.451 - Bars, bottom

Xyp5 #1 – The visual inspection showed a crack on the top surface above the right bar. There was also a crack on the right side of the specimen. Both bars are well covered in corrosion especially on the bottom. The tops of the bars also had a fair amount of corrosion. The half cell numbers on the left side all fell into the 10% probability range. On the right side two values fell into the uncertain range and the other in the 10% probability range. The voltage readings indicated the specimen had failed. The inspection concluded the corrosion to be moderate to significant.

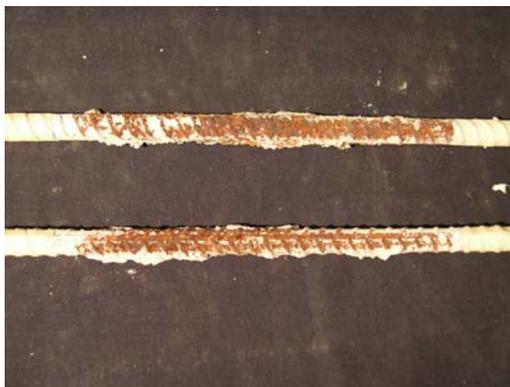
Figure 7.455 - Bars, bottom

Xyp5 #2 – The visual inspection showed that there was a crack on the top surface above the left bars. There was also a crack on the left side. Both of the bars are completely covered in corrosion on the top and bottom. The half cell potential readings showed that all of the values except one on the left side fell into the uncertain range. The lone other value fell into the 10% probability range. The voltage numbers indicated the specimen had reached failure. The inspection concluded the corrosion to be moderate to significant.

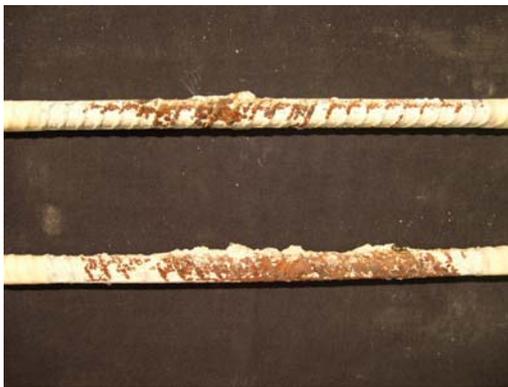
Figure 7.459 - Bars, bottom

Xyp5 #3 – The visual inspection showed a crack on the top surface above the right bar. Both bars were well covered on the bottoms. The tops of both bars also had corrosion areas with scattered spots all along the length of the bars. The half cell potential results reveal that all of the values fell into the 10% probability range. The voltage readings showed that the specimen had failed. The inspection concluded the corrosion to be moderate to significant.

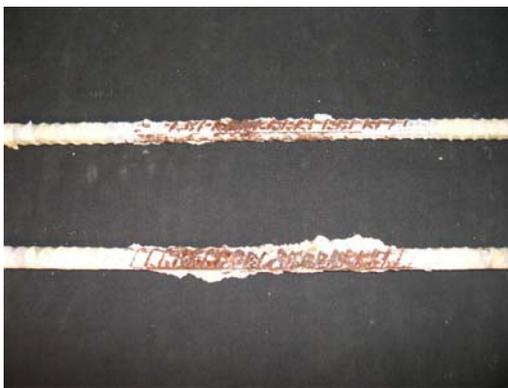
Figure 7.463 - Bars, bottom

Xyp5 #4 – The visual inspection showed that there was a crack on the top surface above the right bar. There were also some cracks on the right side of the specimen. Both bars were well covered in corrosion on both the top and the bottom. The right bar corrosion seemed to be more severe than the left. The half cell potential values showed that the left side had one value in the 10% range and the other two in the uncertain range. The right side numbers were all in the uncertain range. The voltage readings indicated that the specimen had failed. The inspection concluded the corrosion to be moderate to significant.
